BIRCH POND DAM

MA 00237

PHASE I INSPECTION REPORT
NATIONAL DAM INSPECTION PROGRAM

AUGUST 1978

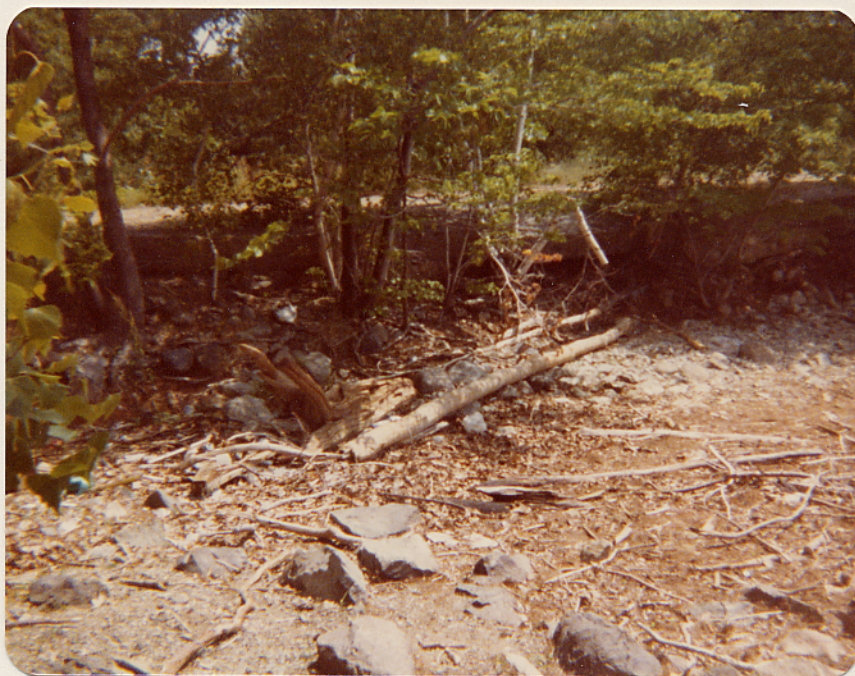
2

b. Dam. The dam appears to be in poor condition. There are many areas on the upstream face where the riprap is sloughed off. In addition, the upstream slope is overgrown with vegetation. The downstream slope is eroded by an occasional motorbike trail. The embankment crest is deteriorated due to improper usage by motorbikes. Other than that caused by general deterioration, there appear to be no serious horizontal or vertical misalignments. There is no evidence of seepage through the embankment.

Upstream Face of Dam

- a. Alternatives. Not applicable.
- b. Operating and Maintenance Procedures.
 - (1) Growth should be removed from the upstream face of this dam and the slope maintained against further erosion by the application of a heavy rock facing.
 - (2) The crest should be brought to true and level grade and surfaced.
 - (3) The spillway channel should be cleaned up and hydraulically improved as much as practicable.
 - (4) Motorbike trails on the downstream face should be filled and seeded and motorbiking on the dam should be stopped.

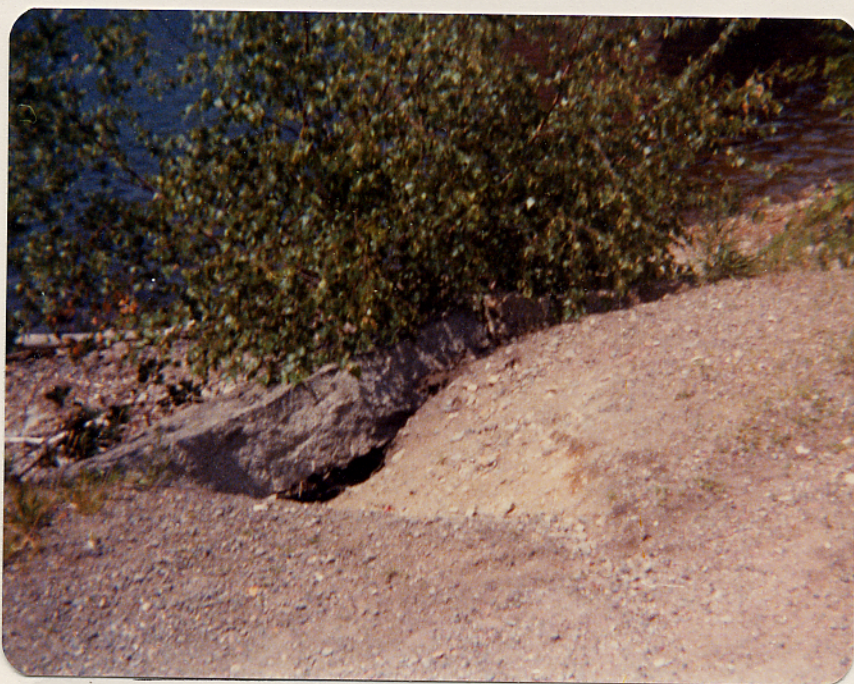
3

Collapse of Upstream Block

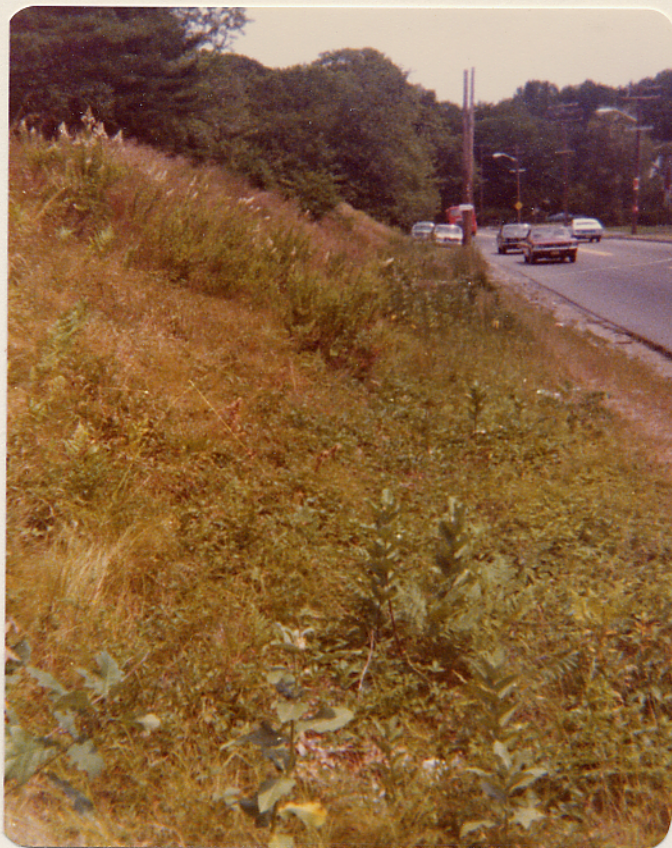
4

Downstream Embankment

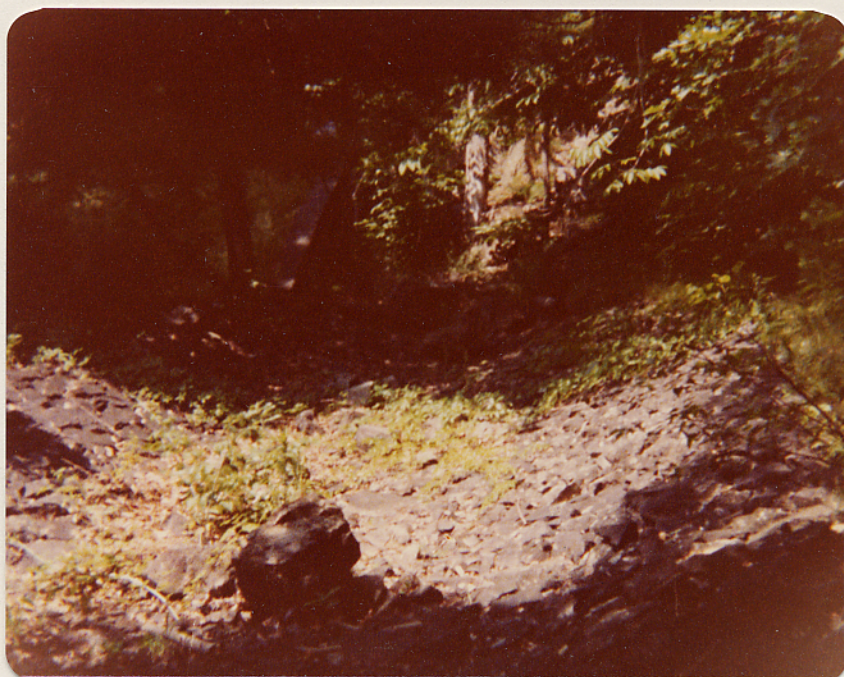
5

c. Visual Observations. Spillway channel is very rough. It could be cleaned up and improved. Beyond the dam, the rock-lined spillway channel is steep. Discharge would not threaten the dam.

Downstream Spillway Channel

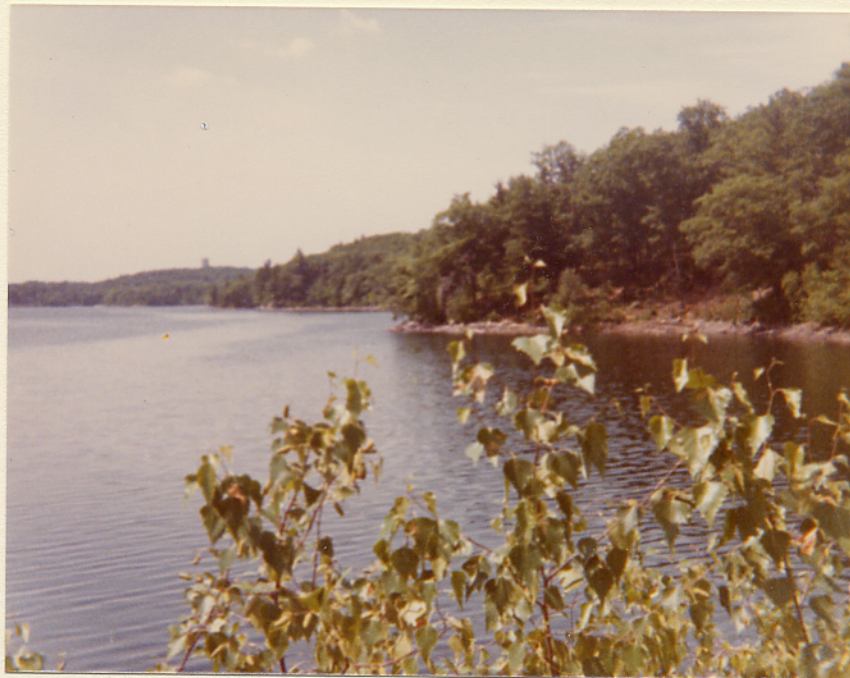
6

View of Reservoir and Shoreline from Dam

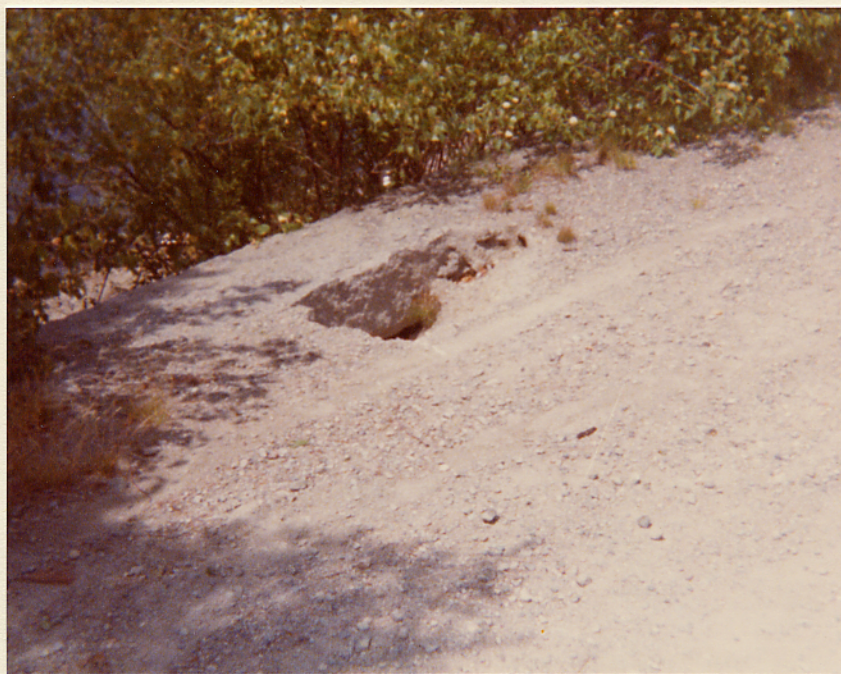
7

Hole at Junction of Granite Block and Crest
